**CITY OF ROCKVILLE HISTORIC DISTRICT COMMISSION
STAFF REPORT**

**September 21, 2004
MEETING NO. 10-2004**

APPLICATION: HDC04-00314

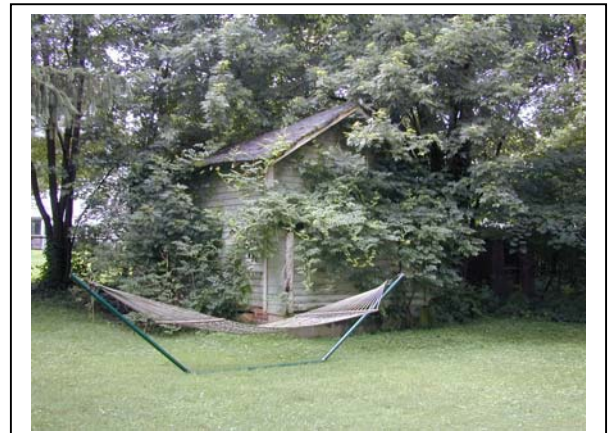
There are two accessory buildings at the rear of the property. The accessory building located in the southwest corner of the lot is the subject of this application. The small wood framed garage fronts the [now abandoned] alley. At the time of designation in 2003, this building was noted as being in very poor condition, with roof, wall and foundation damage.

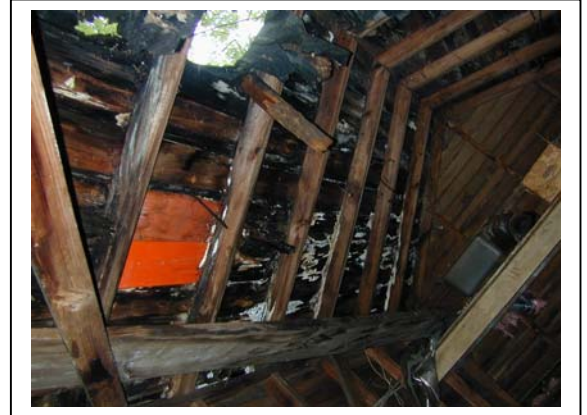
Interior view of roof

The proposal is a follow-up of the designation discussion and considerations. The accessory structure is in derelict condition. The walls are falling away from the minimal foundation, and there are holes in the roof.

STAFF RECOMMENDATION: Staff recommends that the HDC approve this demolition, as part of the designation consideration from early 2004.
